MARIENTHAL - AN ECOLOGICAL APPROACH

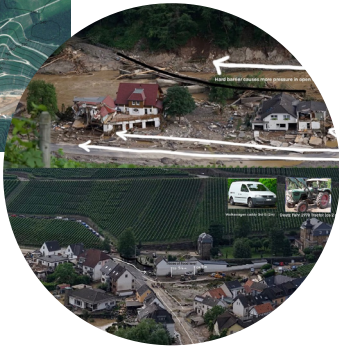
Ahrthal forms a 90km valley going through Western Germany, surrounded by steep hills. After the destructive flood summer of 2021, authorities and experts are suggesting to give more space to the water that flows through the bottom. We propose an ecological solution to make this landscape more capable of handling limited amounts of excess water. By removing hard barriers at the base and reintroducing native species and allowing the river to move and erode within a designated area without compromising safety of the people or the aesthetic value of the landscape.

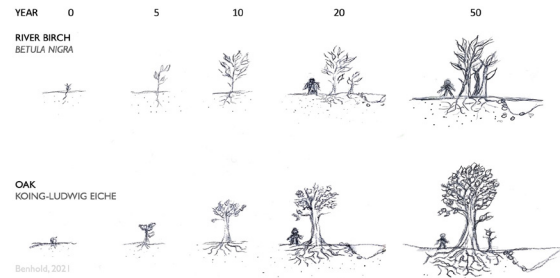
ECOLOGICAL RESTORATION- REWILDING NATIVE SPECIES

By digging the river to a slightly lower elevation, and using the excess sediment to create variations in the sediment rather than flat surface, it can contain water in a safe area. The slight expansion of the river ensures that. It is still able to flow, as it usually is a relatively small river; but still reducing the risk of flooding and funnel effect.
